“Strategic Innovation Program (SIP)

– Automated Driving System”

**Survey Research on the Precise Docking of
Next-Generation Transportation Systems
Report**

March 2018

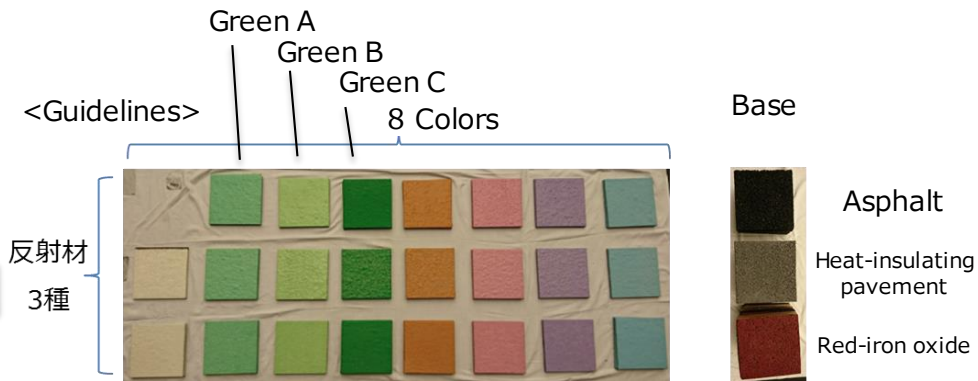
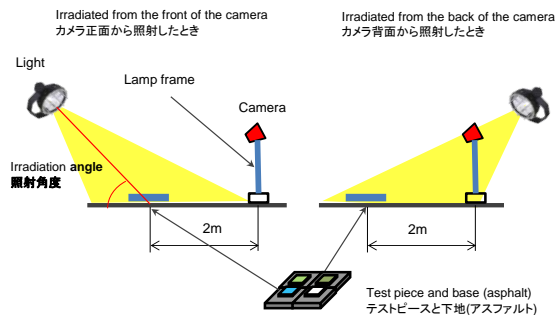
■ Combinations of lab experiment conditions

- Measure the camera recognition image contrast ratio for the different colors used in the guidelines under various lighting conditions, etc.
- Confirm the "system recognizability" through the experiment results, and thereby decide the guideline color, etc.

Test Piece	Color	White, Green A, Green B, Green C, Orange, Pink, Purple, Blue	
	Reflecting Material	Glass beads, AWT, Bright Grip	
	Base	Asphalt, red iron oxide, heat-insulating pavement	
Time	Day	Sunshine	Morning, midday, evening (reproduced with lights)
		Light dir.	Front-lit, backlit, angle
		Wetness	Dry, Wet
	Night	Street Lamps	With street lamps, without

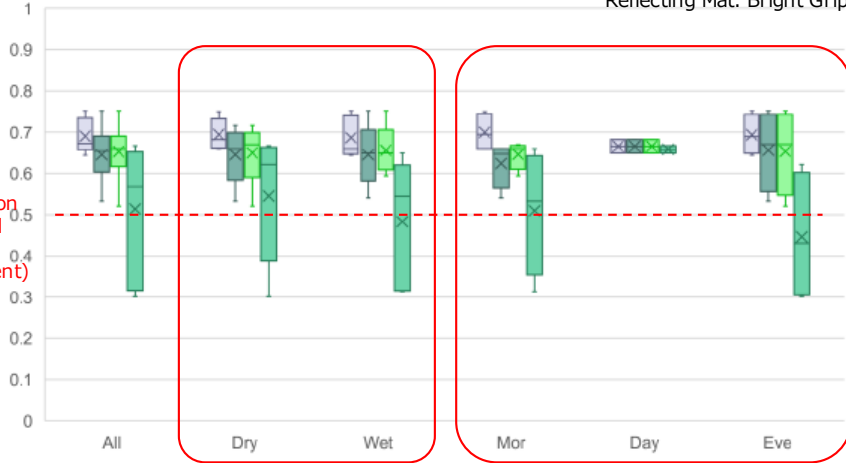
Basic Performance Evaluation:

Morning / Sun / Evening + Dry / Wet

Image contrast of candidate colors, grouped

System recognition threshold (During experiment)

No difference between dry and wet

Performance varies by color under morning or evening sunlight

– While both Green A and B had an image contrast ratio close to White during the day, Green B was measured to have higher image contrast than A.

Green B selected as green candidate

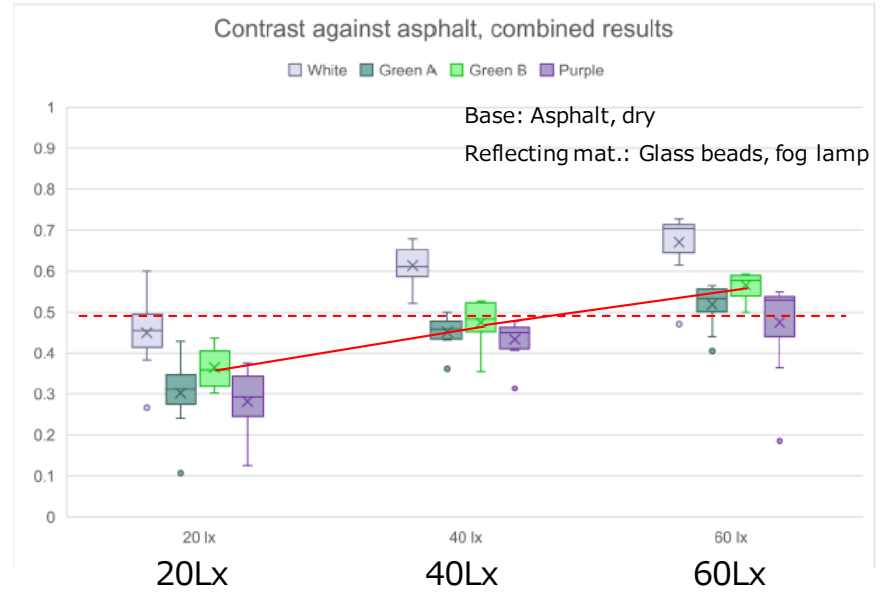
Confirmation of street lamp luminosity

Nighttime headlight evaluation:

- Contrast ratio improves with greater luminosity
- It is possible system recognition will become impossible based on luminosity

– Based on the correlation data of street light luminosity and contrast ratio, we plan to determine the recognizable luminosity range.

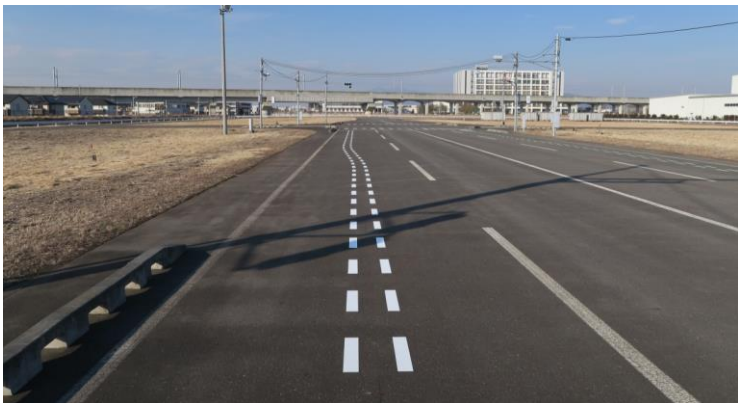
■ Proposal 2 (White)

Proposal set as a reference for the experiment.
Proposal 3 (Green, Annotated)

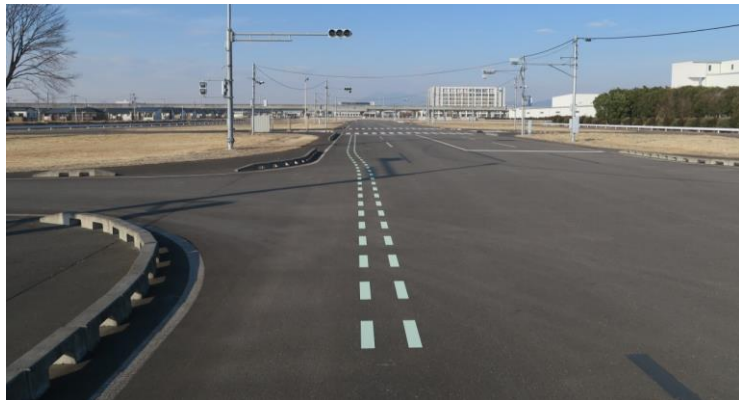
■ Guideline 1 (Green)

A proposal using green to avoid confusion with official traffic lines.
Proposal 2 (White)

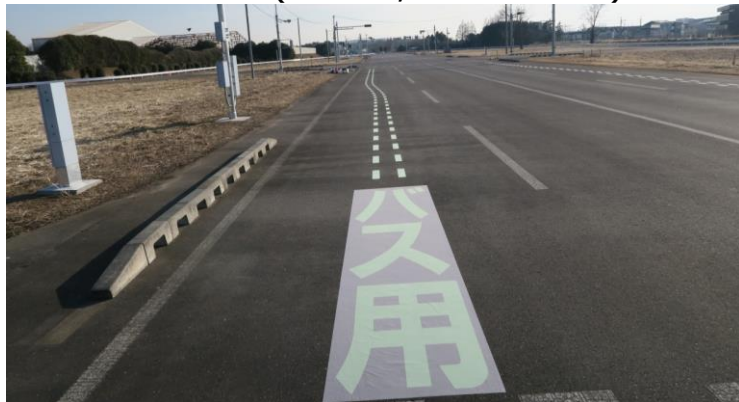
■ Guideline 3 (Green, annotated)

A proposal which places a note on the road to indicate bus-only use.

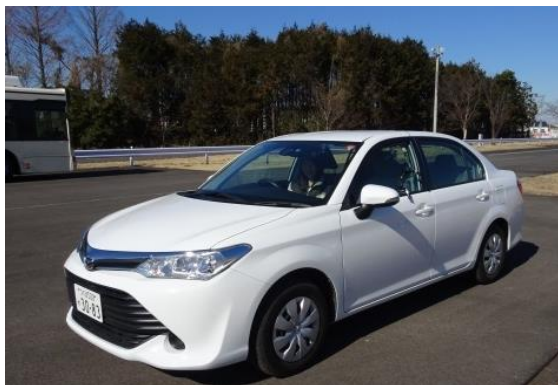
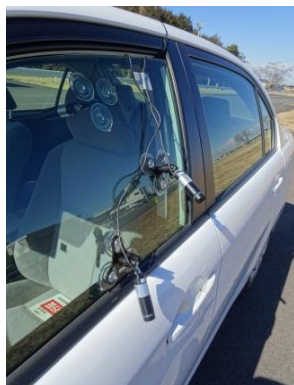
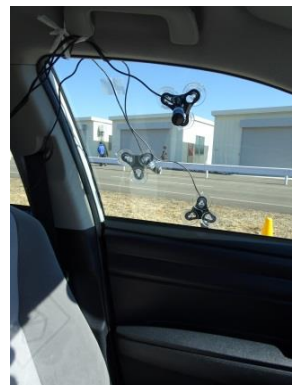
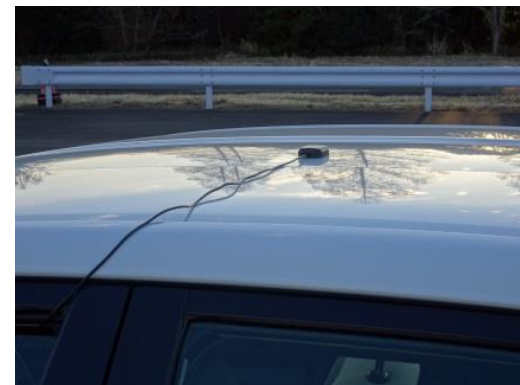
* Additionally, in order to eliminate abnormal factors other than the guidelines, a video camera was installed inside the car so that the drivers line of sight and steering wheel handling were recorded.

■ Video

(side-mounted)

■ Video (Interior)

■ GPS

■ Car used

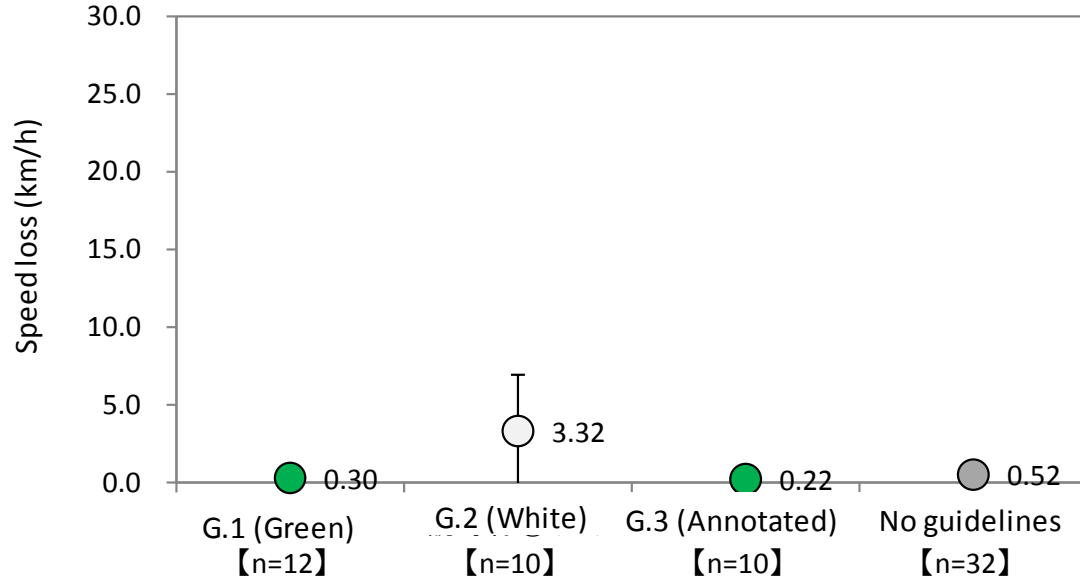
■ Reduction of speed caused by passing through the guidelines (Entry speed - lowest speed while passing through the guidelines)
(standard devia

- The speed change observed during the first experience (first sight) of driving through the guidelines is as per the below.
 - Based on the speed at the entry point to the guidelines, and the lowest speed while passing through, no large difference was observed between the different guidelines.

*Error bar indicates the standard deviation.

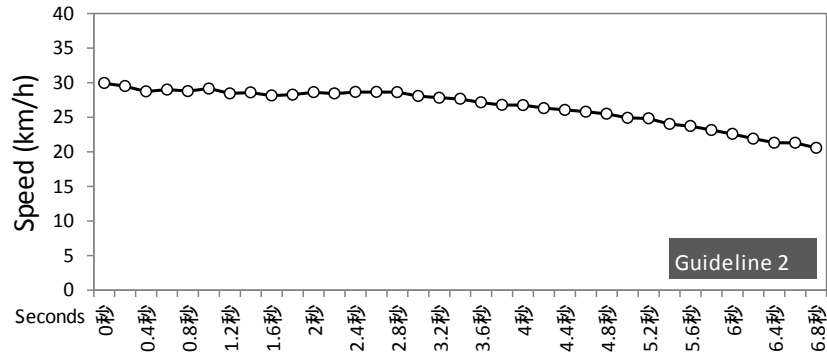
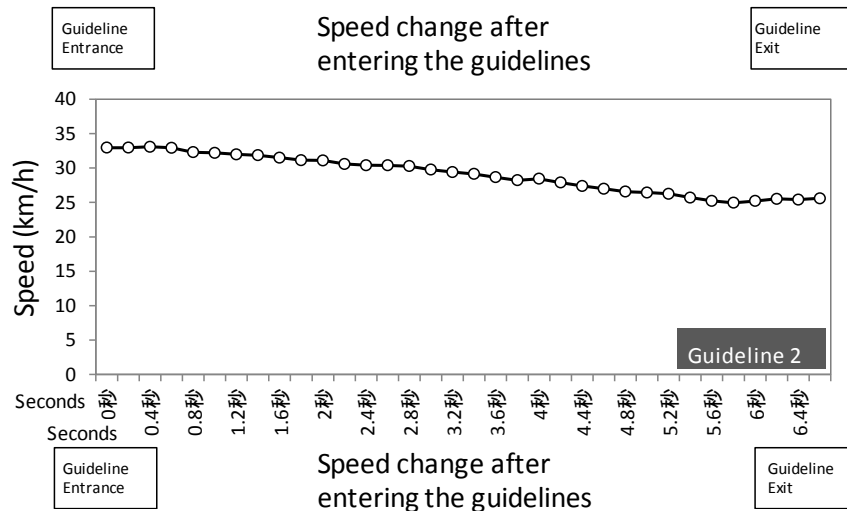
<Examples of speed changes>

1.) Monitor 15: Speed reduction: 9.3 km/h
Acceleration 0.04G (Guideline 2 (White))

- Speed gradually decreased after entering the guideline area, it is believed the accelerator was lightened.
- The monitor answered "I did not brake" in the post drive survey.

2.) Monitor 19: Speed loss 8.0km/h
(Guideline 2 (White))

- Speed gradually decreased after entering the guideline area, it is believed the accelerator was lightened.
- In the post-drive survey, the monitor answered, "I did not slow down due to the guidelines, but rather because the lanes were being reduced ahead."

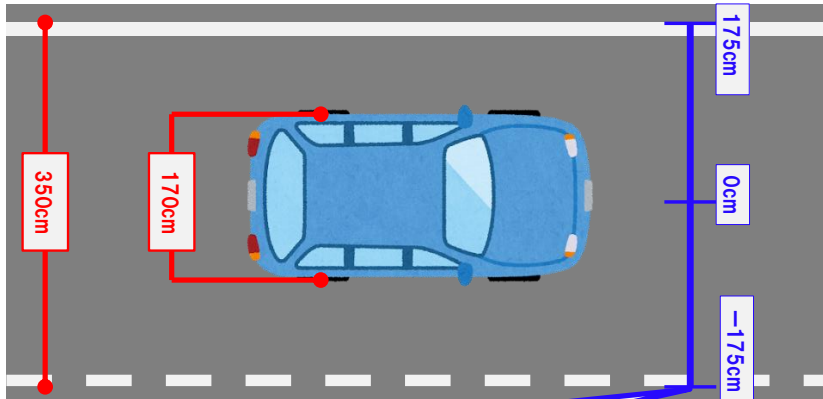
■ Vehicle driving position

Definition of travel position

- The “vehicle center” is used
- Left drift is “+”, right drift is “-”

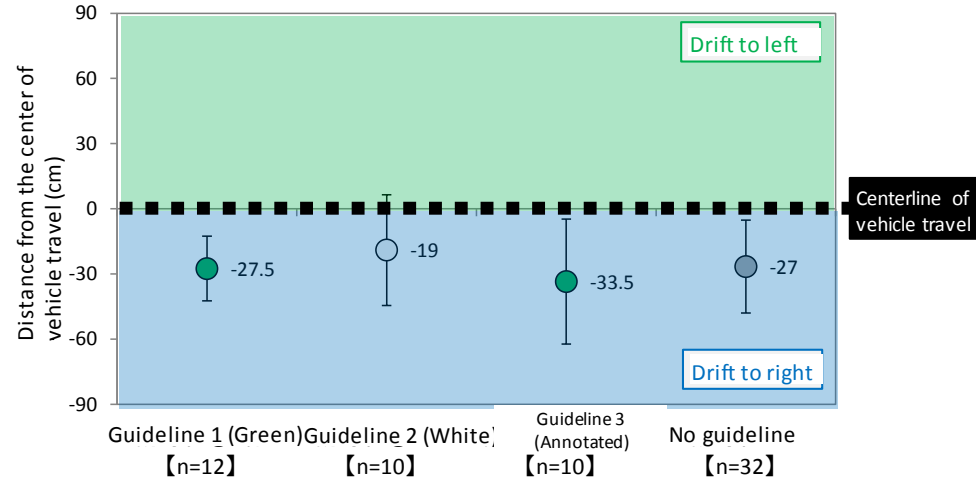
■ Vehicle driving position (entrance area) (standard deviation)

- The following “**entrance driving position**” observations were made when driving through the first guidelines
- No major differences were observed between the guidelines, and there was overall a right-drifting tendency.
- No major differences were observed in the guideline and no guideline areas.

* Error bar indicates standard deviation.

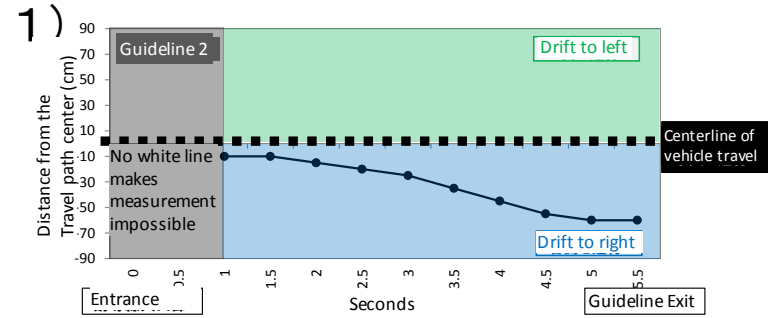
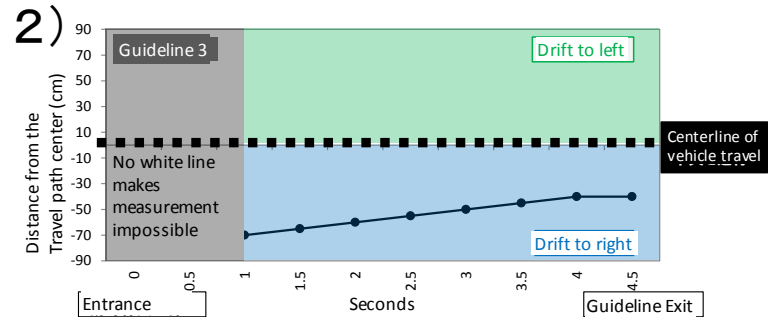
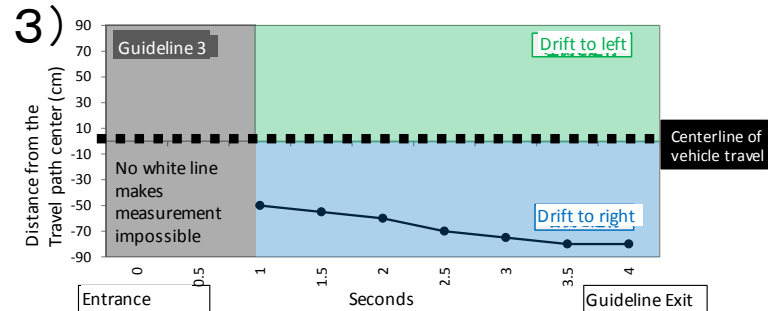
1.) Monitor 18: Lateral movement 50cm (Guideline 2 (White))

- Drifted to the right in the guideline area.
- In the form-based survey, the monitor answered, "I was uneasy because I didn't know what kind of line it was," and "I moved to the right to avoid driving on the line."

2.) Monitor 26: Lateral movement 30cm (Guideline 3 (Annotated))

- Entered on the right side and moved to the left.
* Also drove on the right for other guidelines.
- In the form based survey, the monitor answered, "I thought it was a bus lane, and if I saw it while driving on regular roads, I would not use that lane."

3.) Monitor 31: Lateral movement 30cm (Guideline 3 (Annotated))

- Drove on the right as far as the lane allowed in the guideline areas.
